## Korenix JetNet Industrial Managed Switch 5010G SOFTWARE RELEASE Notes

### About This Software Version

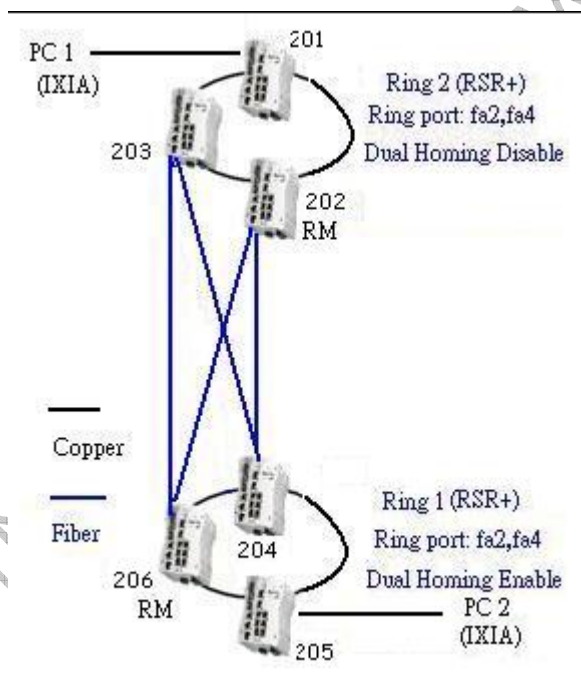
- Bootloader v1.6.2.10 should use firmware 2.1 or above.
- To applied GVRP function into trunk group should configure port trunk firstly and this function only present in Web interface, not available in command line interface (CLI).
- In dual homing architecture, only provide 7 uplink paths. If uplink path over 7 will cause video stream abnormal.
- In following network architecture, if plug out the any path either device 203 and 206 or device 202 and 204 will result the connection break down. This testing result only present in one-way ping command testing.
